Analysis of Green Roofs Ability to Mitigate Hail Damage on Roofs

Abstract- Green roofs can significantly reduce, and in most cases eliminate, the damage and cost of roof repairs caused by hailstorms. Green roofs act as a buffering layer of substrate and plants, absorbing the destructive impact of hail hitting the surface during a hailstorm. Anticipating severe weather and implementing cost-effective protection strategies, such as green roofs, can result in significant savings for property owners and insurance companies. This study demonstrates and quantifies the advantages associated with the use of green roofs to prevent hail damage and associated cost benefits. Testing and data collection in this study were based on the current recommended testing method, UL 2218 Standard for Impact Resistance of Prepared Roof Covering Materials, testing impact resistance by dropping steel balls onto the roof surfaces from various heights.

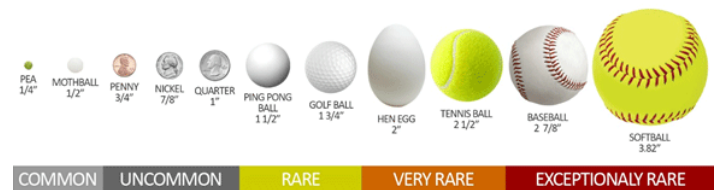
Figure 1: The range and level of rarity of various hail sizes. Based on chart by Michael S. Lewis, NOAA.

A thunderstorm producing hail is known as a hailstorm. Hail is formed from droplets of water carried upward by the updraft of thunderstorms. When the droplets reach colder atmospheres, the water freezes into ice. The ice droplets fall and accumulate moisture on their surface which also freezes. The frozen droplets can be carried back into the upper regions of the storm if the updraft is strong enough. As this cycle continues, hailstones increase in size until their weight is too great for the updraft to support, allowing the hail to fall to the ground. Severe hail is defined by the National Weather Service as hailstones measuring at least one inch in diameter, however, under some circumstances, hailstones can reach or exceed a diameter of 15 cm (6 in). The national record (set in 2010 in South Dakota) was 20 cm (8 in) in diameter (almost the size of a volleyball) and weighed almost 907 grams (2 pounds). According to the National Weather Service (NWS) the largest recorded hail in Colorado was 12.27 cm (4.83 in) in diameter (almost the size of a softball) and weighed just over 225 grams (a half-pound) (Rice 2019, NOAA 2019). Various ranges and level of rarity of hail sizes are described in Figure 1.
